# Safety Concern Notice

## **HVAC pull-out type electrical disconnect devices**

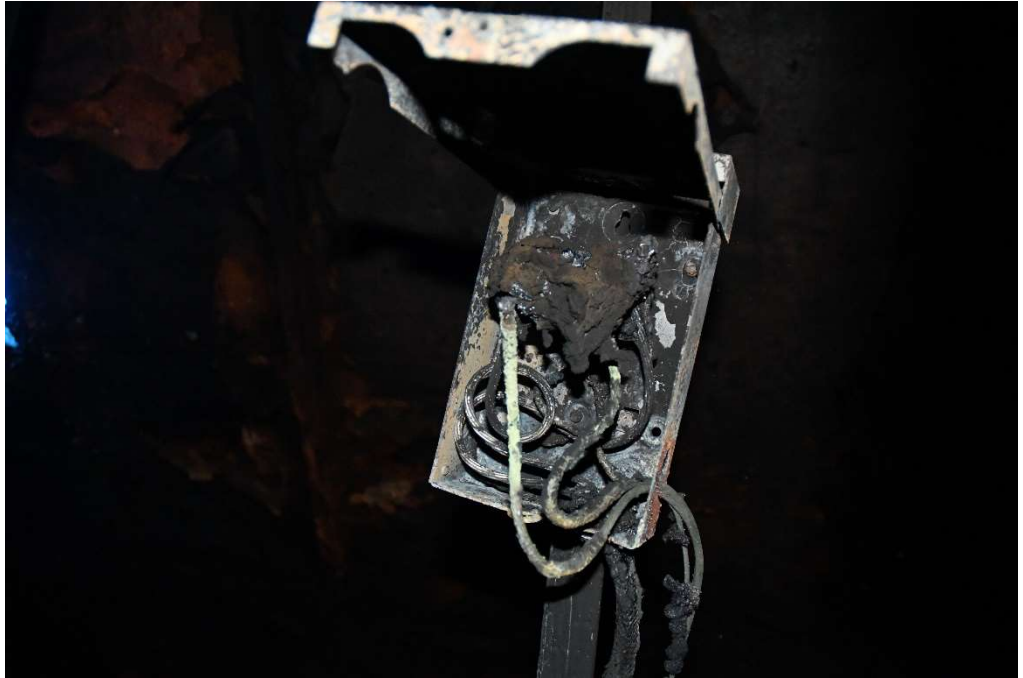
A multi-family development in Columbia, Tennessee has experienced multiple damaged disconnects that have been installed for use with attic air-handler/furnaces. As many as 14 have melted and had to be replaced. One apartment unit caught fire and was destroyed in December 2025. The models installed in this development were the Eaton DPU222R. Even though the electrical load was approximately 42 amps and the disconnect is rated at 60 amps, they still failed because of the continuous load and misuse.

Disconnect in fire damage condo

This notice is to inform home inspectors, electricians, HVAC technicians, and code compliance inspectors of this issue. Careful inspection of these devices is imperative for proper use and to reveal any signs of heat distortion. The failure point is primarily at the pull-out handle. Inspectors should look carefully for any deformation near the top of the plastic dead-front cover and pull-out handle. The Tennessee state fire marshal's office has recently sent notice to electrical code inspectors to fail any installations of these disconnects when used with resistive heating loads.

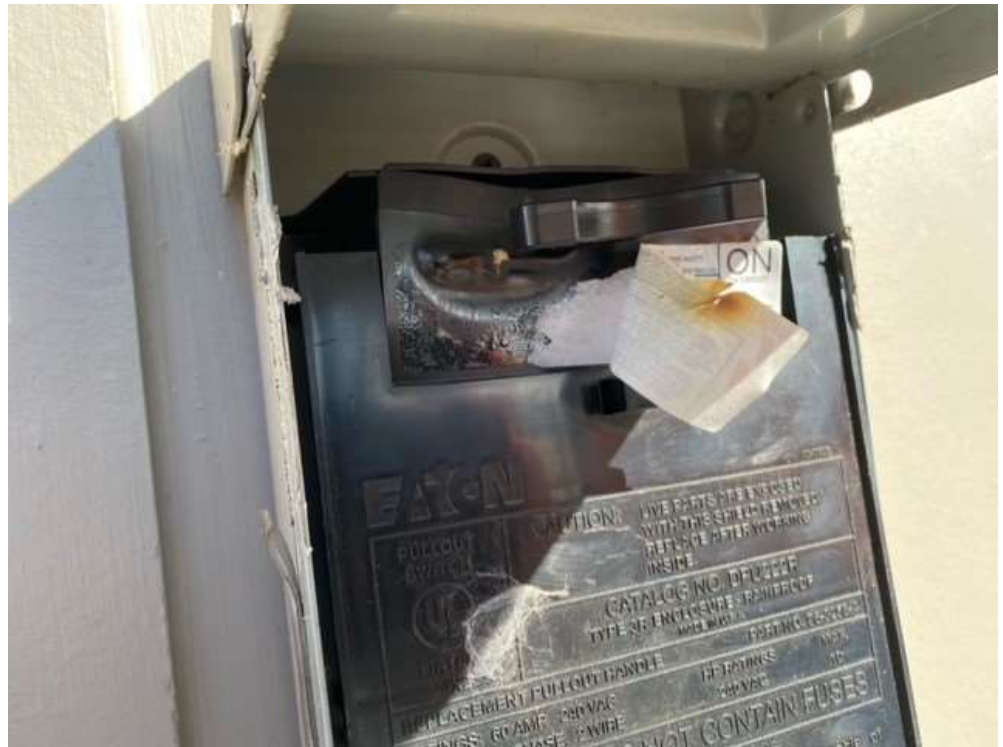
There have been several documented cases of failures with pull-out type disconnects that are commonly used with HVAC equipment. The concerns involve the tendency for these devices to overheat and melt when the electrical load lasts for an extended period of time.

Melted pull-out handle
